Subject: F33615 - 90 - D - 4014, Order 04,
O&M Effort for the Bioventing System at the 7th Street BX Service
Station (May 1992 through March 1993), Eglin, AFB

**CARBON DIOXIDE LEVELS DURING BIOVENTING
AT 7TH STREET BX SERVICE STATION (5/20/92 - 3/11/93)
EGLIN AFB**

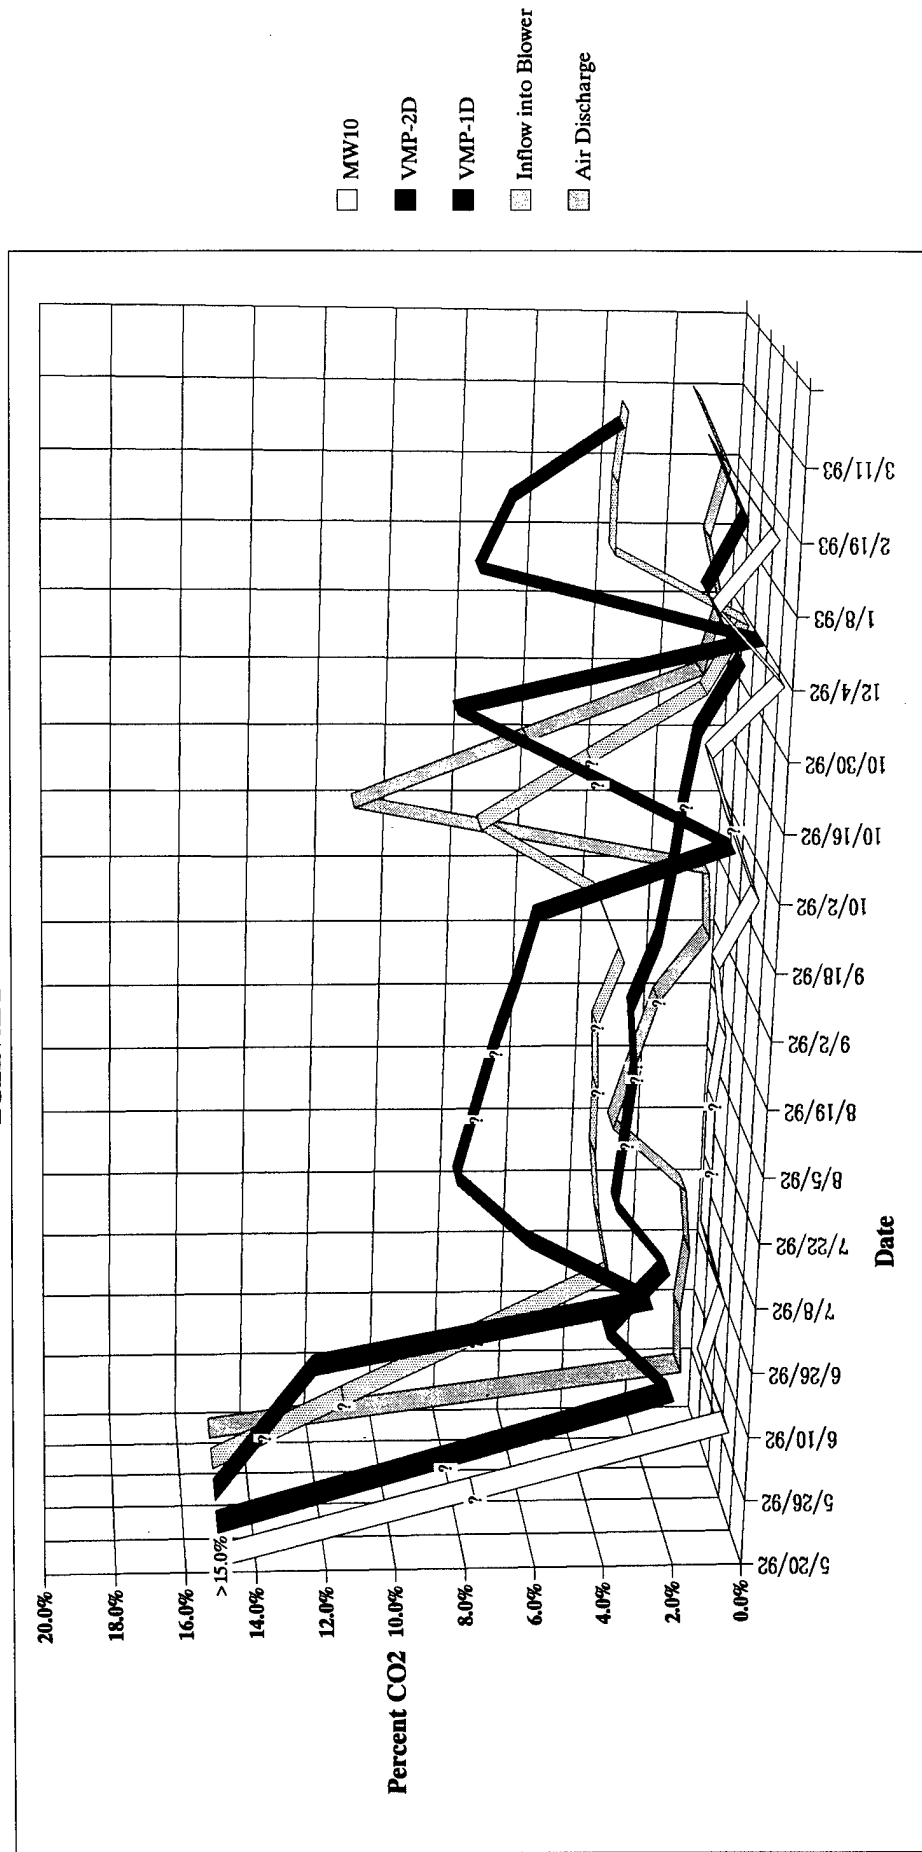
Figure 1.a.b

Note: "?" indicates no data was recorded on this date; slopes are assumed to be linear.

Results of biweekly/monthly concentrations of oxygen, carbon dioxide and Total Hydrocarbons throughout the bioventing system are presented in Table 2 and depicted in the attached charts. These results continued to indicate increased biological activity in the subsurface and suggest potential increase in aerobic bacterial population. Results indicate oxygen supply to the subsurface has been adequately sustained. Notably, pre-venting condition indicated a soil oxygen concentration of zero at VMP-1 and VMP-2. As of March 11, oxygen concentrations at monitoring locations VMP-1 and VMP-2 have increased to values ranging from 15.5 to 16.5 percent. In contrast, carbon dioxide that was in excess of 15 percent prior to startup has declined to values ranging from 2.0 to 4.2 percent at all monitoring points. Available data indicate a rapid decline in total hydrocarbon concentration over the past four months (December through March). Volatilization and to a greater extent biodegradation are believed to be responsible for the total hydrocarbons removed.

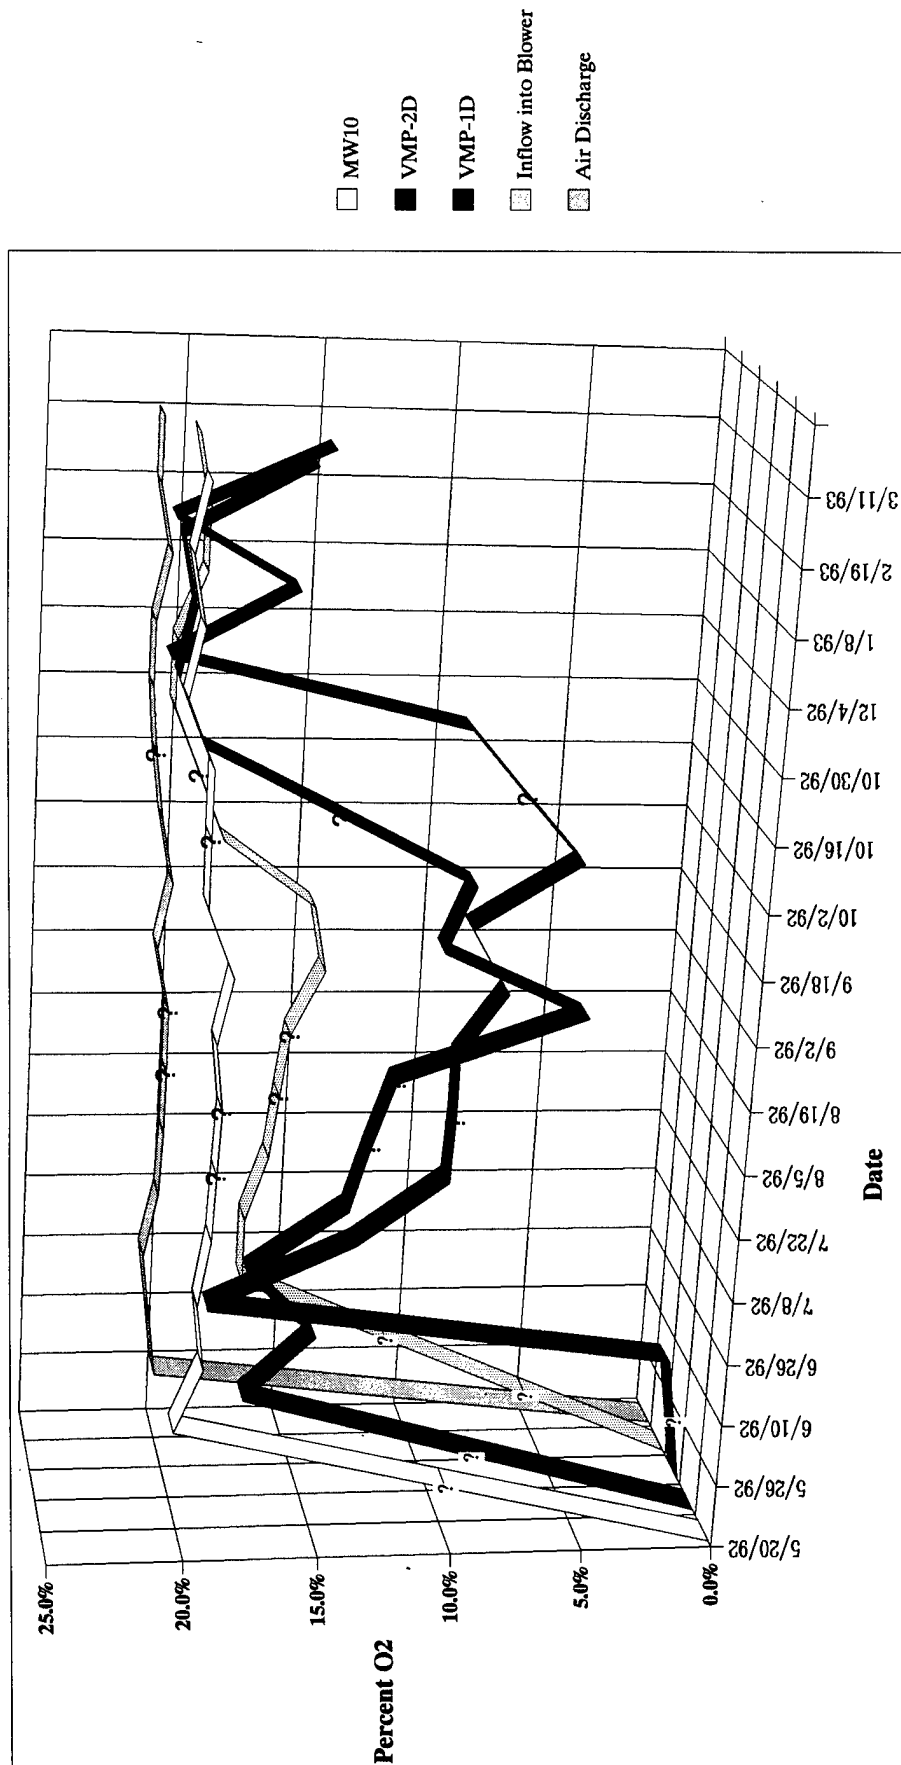
Figure 1.c

OXYGEN LEVELS DURING BIOVENTING AT 7TH STREET BX SERVICE STATION (5/20/92 - 3/11/93) EGLIN AFB

Note: "?" indicates no data was recorded on this date; slopes are assumed to be linear.

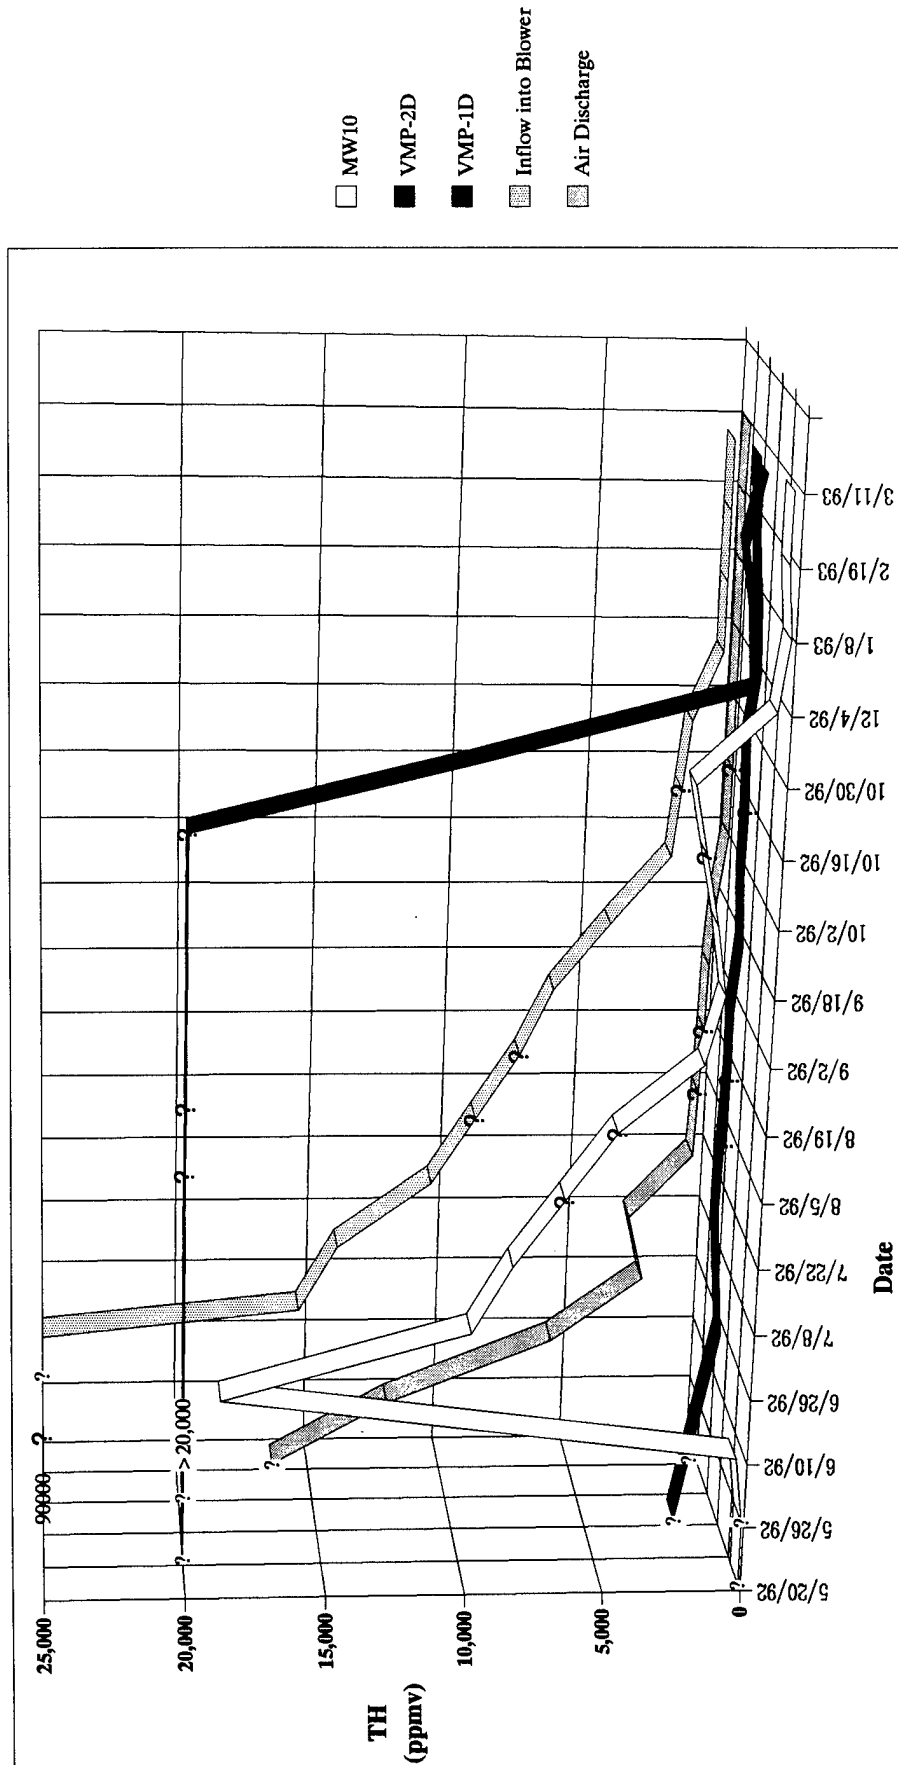
**TOTAL HYDROCARBON LEVELS DURING BIOVENTING
AT 7TH STREET BX SERVICE STATION (5/20/92 - 3/11/93)**

Note: "?" indicates no data was recorded on this date; slopes are assumed to be linear.
